GERMAN SELF-PROPELLED GUNS

**Self-propelled artillery
anti-tank and anti-aircraft guns**

Gordon Rottman

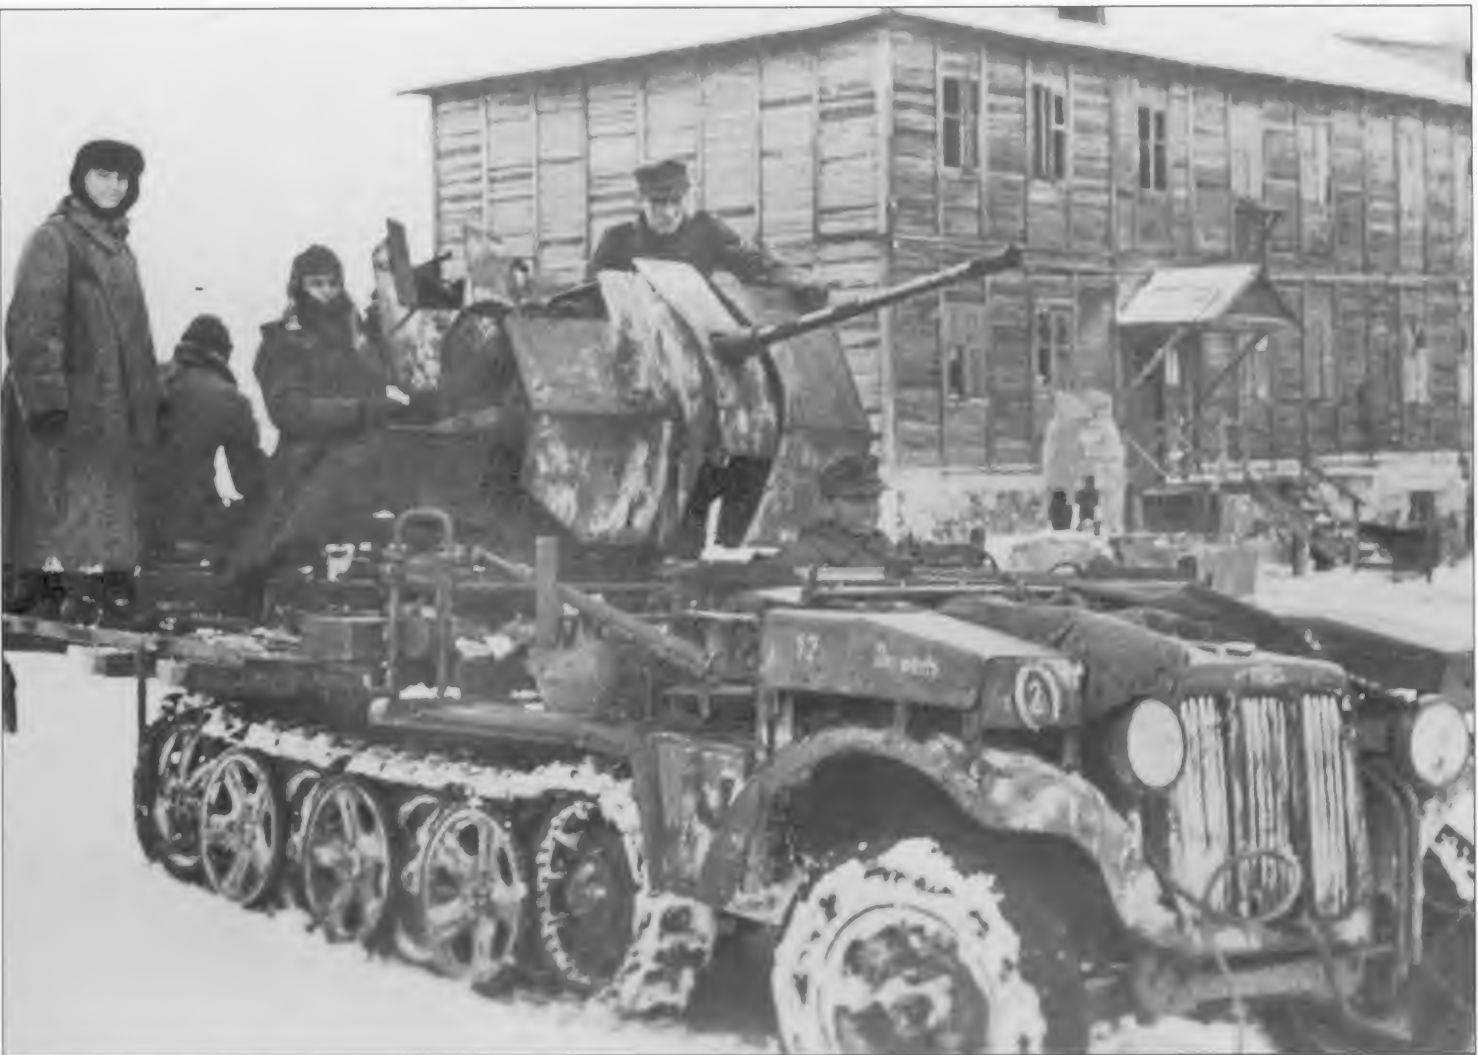
This 2cm FlaK 38 L/112.5 on a Sd.Kfz.10/5 half-track has managed to retain the protective covers for both its fender-mounted carbine racks. A carbine is lying on the seat beside the driver where it can be more rapidly retrieved. The reminder of how the cover fitted, Vorwärts, is painted in white Gothic script on the carbine protective cover. Occasionally a 3.7cm PaK 35/36 or 5cm PaK 38 anti-tank gun was retrofitted on Sd.Kfz.10/4 or 10/5 chassis by units in the field.

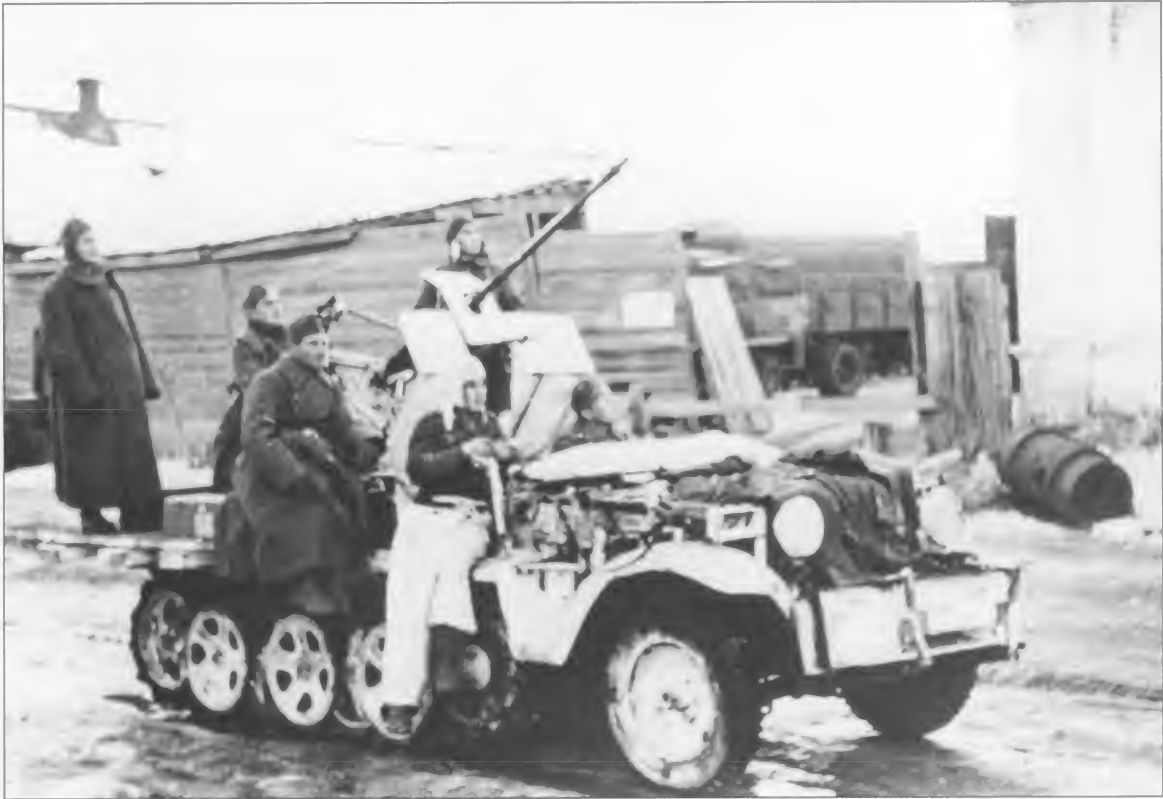
This 2cm FlaK 38 on a Sd.Kfz.10/5 half-track has been whitewashed. A canvas tarp covers the hood and engine grill in an effort to keep the engine from freezing. The crew's carbines are stowed unprotected in the fender racks. Russia, winter 1942/43.

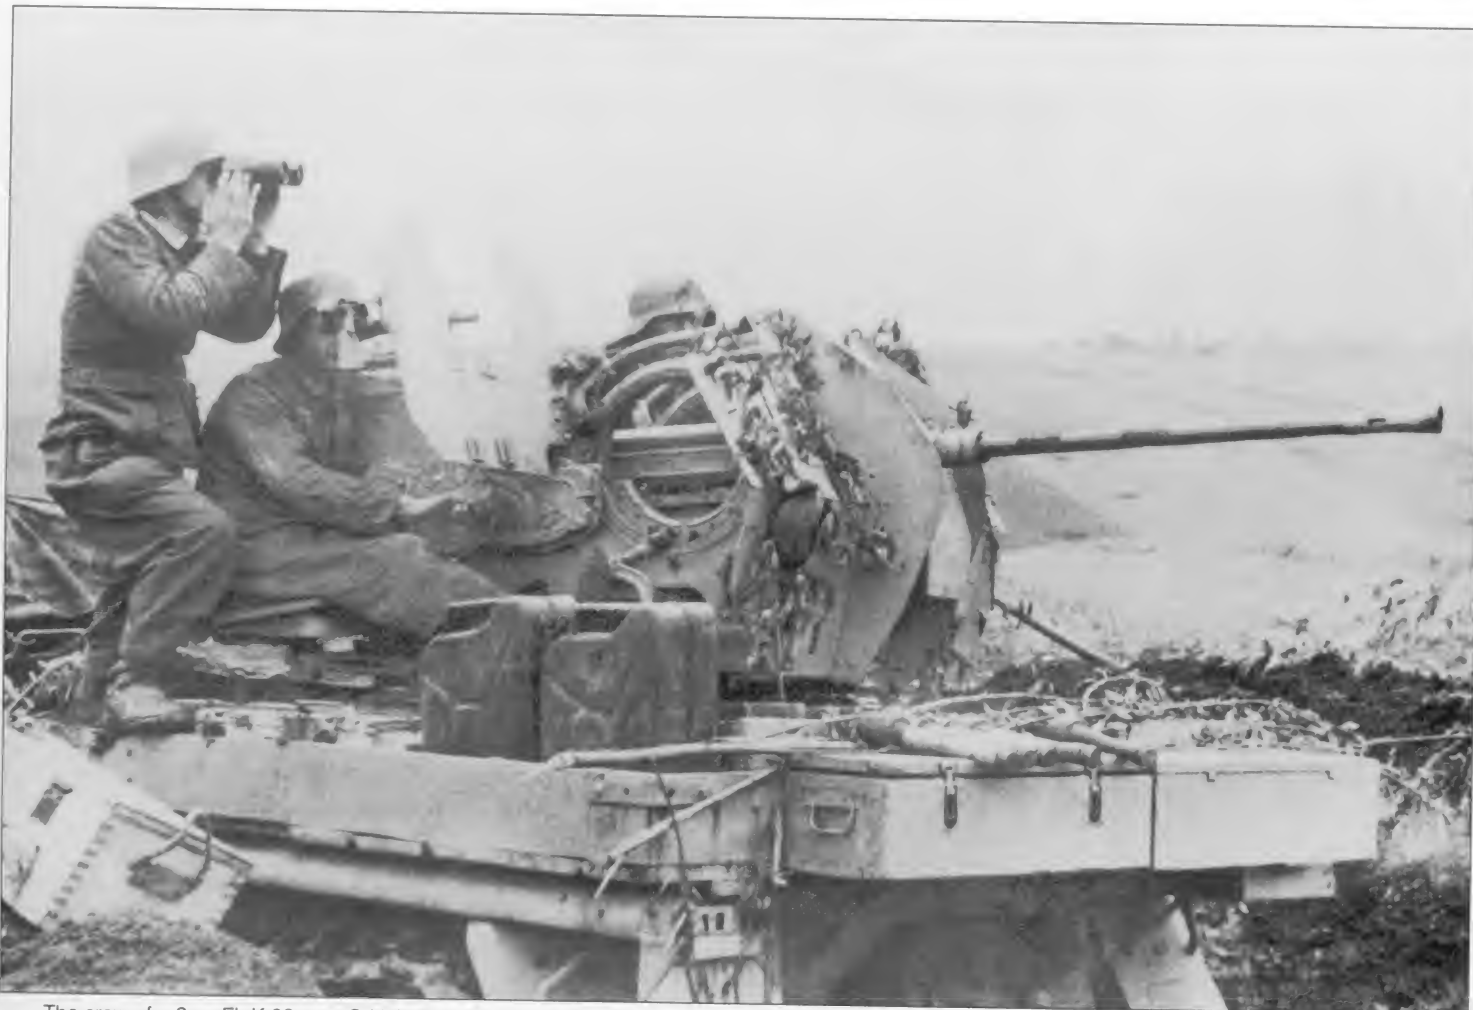
The crew of a 2cm FlaK 38 on a Sd.Kfz.10/5 half-track engages ground targets from a dug-in position. Besides being an effective antipersonnel weapon, the 2cm gun was deadly to lightly armored vehicles. The sideboards have been removed from this vehicle. Both the FlaK 30 and 38 used 20-round magazines. From most angles the FlaK 38 can be differentiated from the FlaK 30 by the former's separate smaller gunner's shield on the right side of the gun, the large circular elevating trunnions, and the flash suppressors as described previously. Note the Stg.24 stick hand grenades on the rear storage boxes for close-in defense of the gun position.

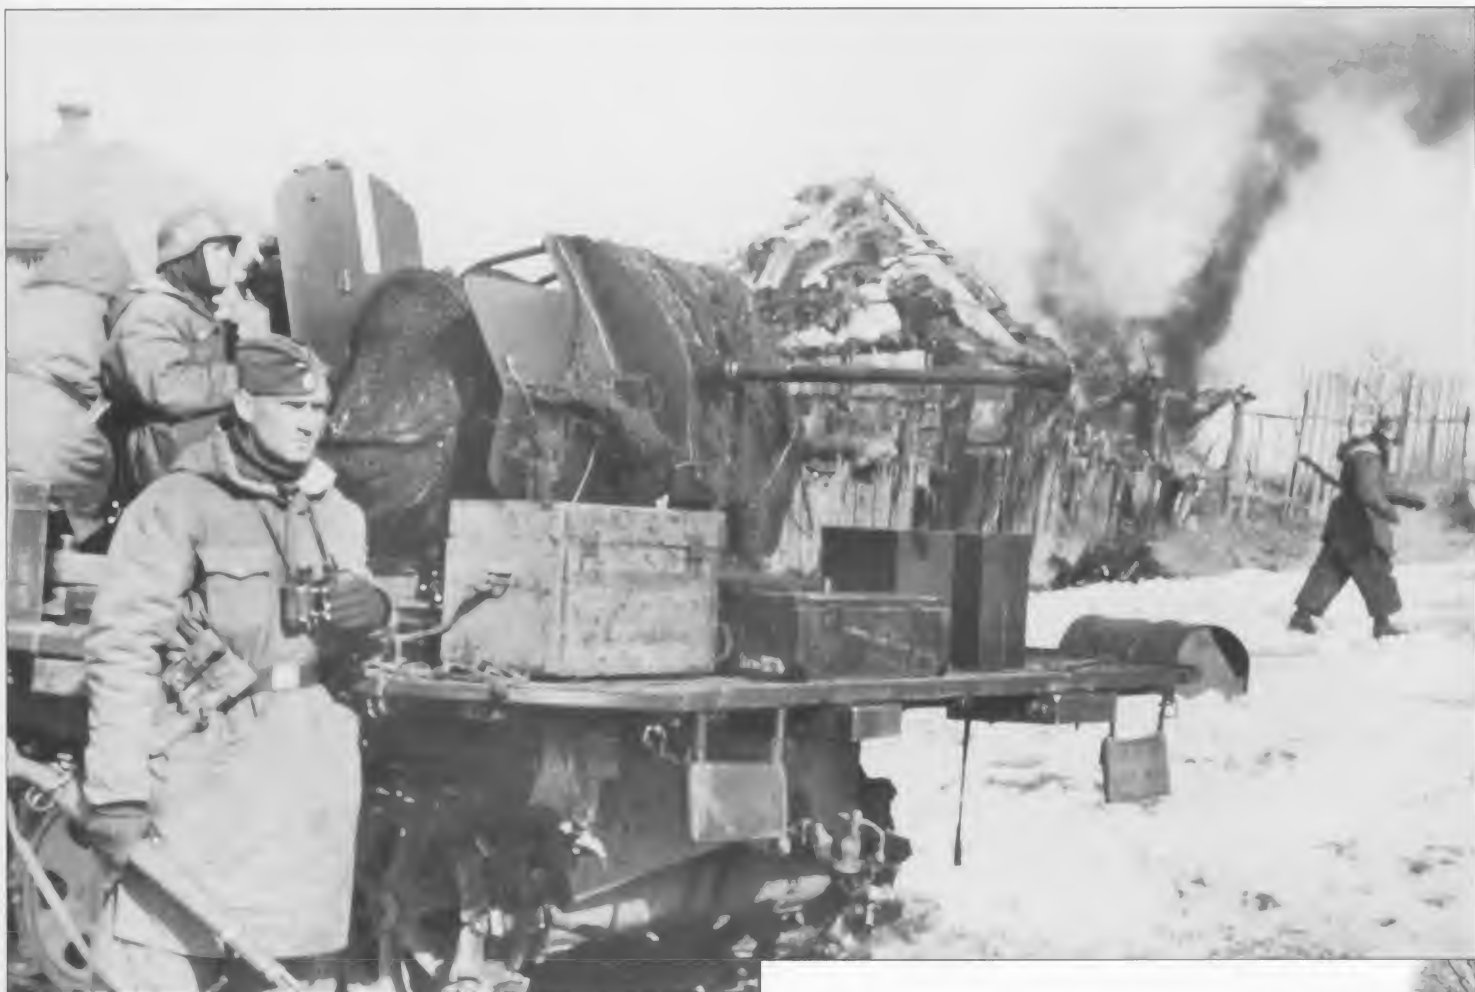
A German SS unit leaves a Russian village devastated as a 2cm FlaK 38 on a Sd.Kfz. 10/5 half-track covers the infantrymen. The mesh housing on the right side of the gun prevented ejected cartridge cases from hitting nearby crewmen. It was frequently removed though. Vehicle crews scrounged all sorts of boxes, cases, and containers in which to carry personal and crew gear. The gun commander, though carrying a Kar.98k carbine, wears MP-40 machine pistol magazine pouches. He had probably picked up another crewman's weapon to take long-range shots. He is wearing the SS fur lined anorak.

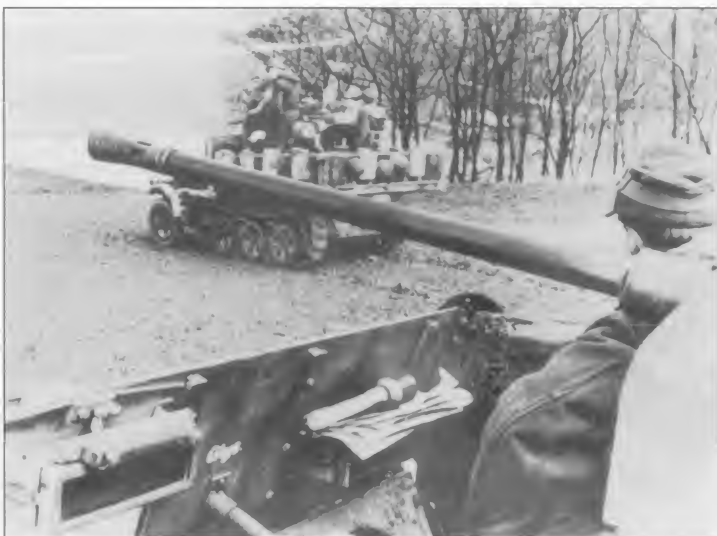
Two 2cm FlaK 38 guns on a Sd.Kfz.10/5 half-tracks move forward to support an infantry attack. These are later models, which were fitted with a forward armor shield behind the driver's compartment. The flash suppressor also served as a muzzle break to reduce recoil. On the far half-track the four sideboard-mounted magazine containers can be seen along with the two on the rear tailgate plus stowed steel helmets. Note the conveniently stowed stick hand grenade. The box in which it is stowed contains data sheets with diagrams identifying the vulnerable points on different enemy armored fighting vehicles.

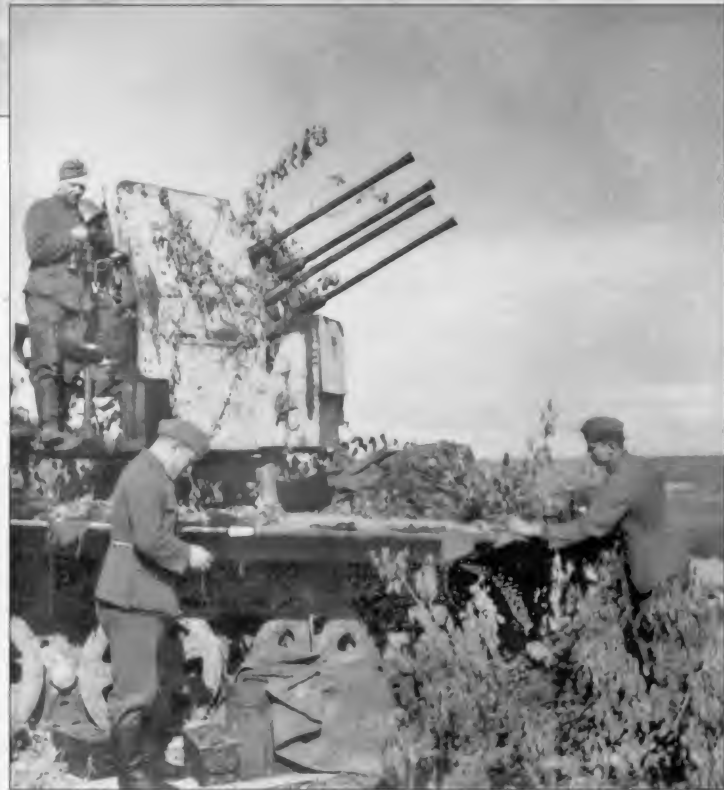
The Sd.Kfz.7/1 medium half-track mounted a 2cm Flakvierling FlaK 38 quad anti-aircraft gun. This was a specially modified version of the 8-ton capacity Sd.Kfz.7 half-track prime mover usually used to tow artillery and was also the standard prime mover for 8.8cm FlaK. On later versions, the cab was provided with light armor plate. Low unarmored steel side boards had to be lowered when the gun was placed in operation. The lowered sideboards and tailgate provided the crew with additional workspace. The gun was mounted on its standard three-arm platform and could be removed from the half-track bed, with the aid of a crane-equipped half-track, and employed on the ground. The gun's high profile served it well in both the air defense and ground supporting fire role, although it made it more vulnerable in the latter role.

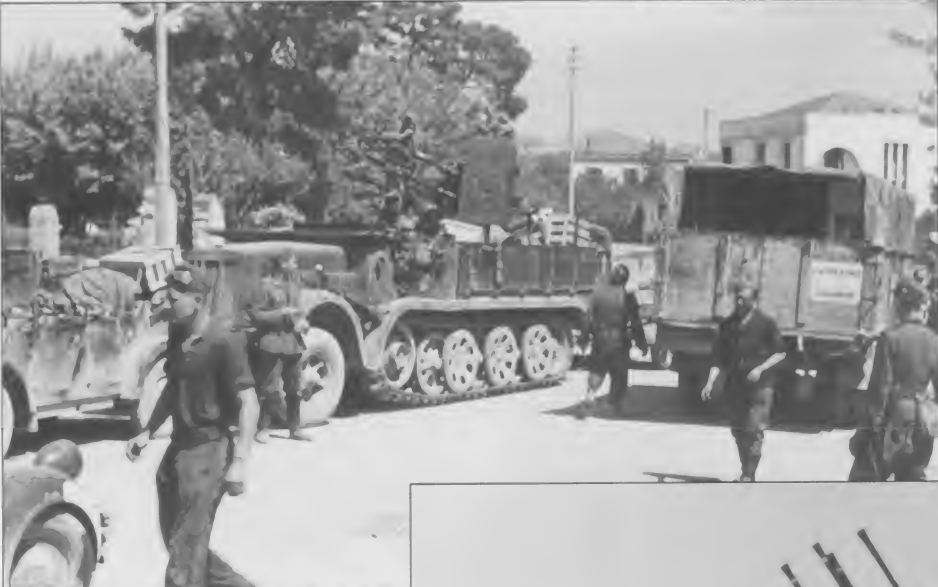
A half-track mounted a 2cm Flakvierling parked in an Italian town as truck traffic passes. The large size of the Sd.Kfz.7/1 half-track is apparent. The vehicle weighed 25,460 pounds (11,550 kilograms) without the gun, ammunition, and equipment.

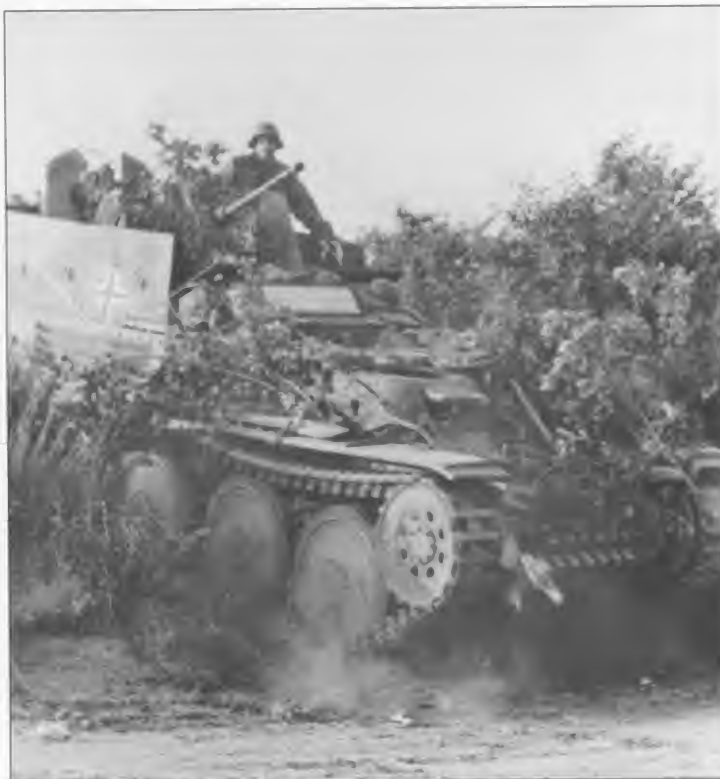
A Flakpanzer 38(t) busts out of the brush. Note that its hinged armored side panels are raised. They were lowered to place the 2cm gun in operation.

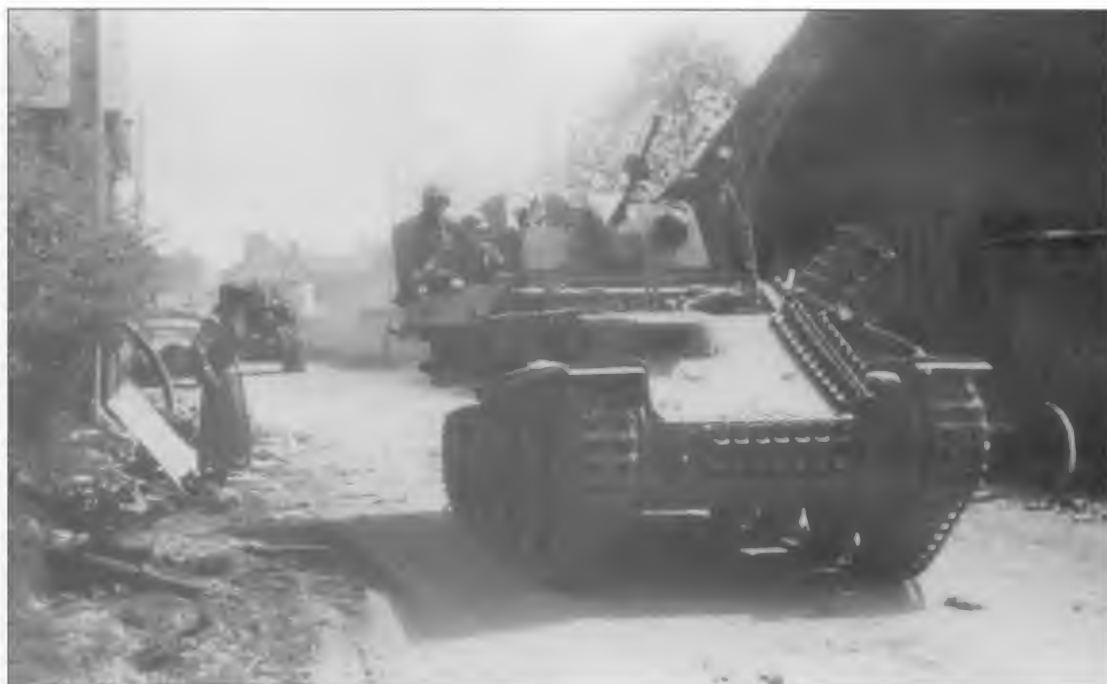
A Flakpanzer 38(t) auf Selbstfahrlafette 38(t) Ausf.L (Sd.Kfz.140), from SS-Flak-Abteilung 12 rushes through a dust-filled Norman village in June 1944. The vehicle mounts a 2cm FlaK 38 and carries 1,040 rounds of 2cm ammunition. Built on a Pz.Kpfw.38(t) chassis, it had a crew of four. Only small numbers of this vehicle were built.

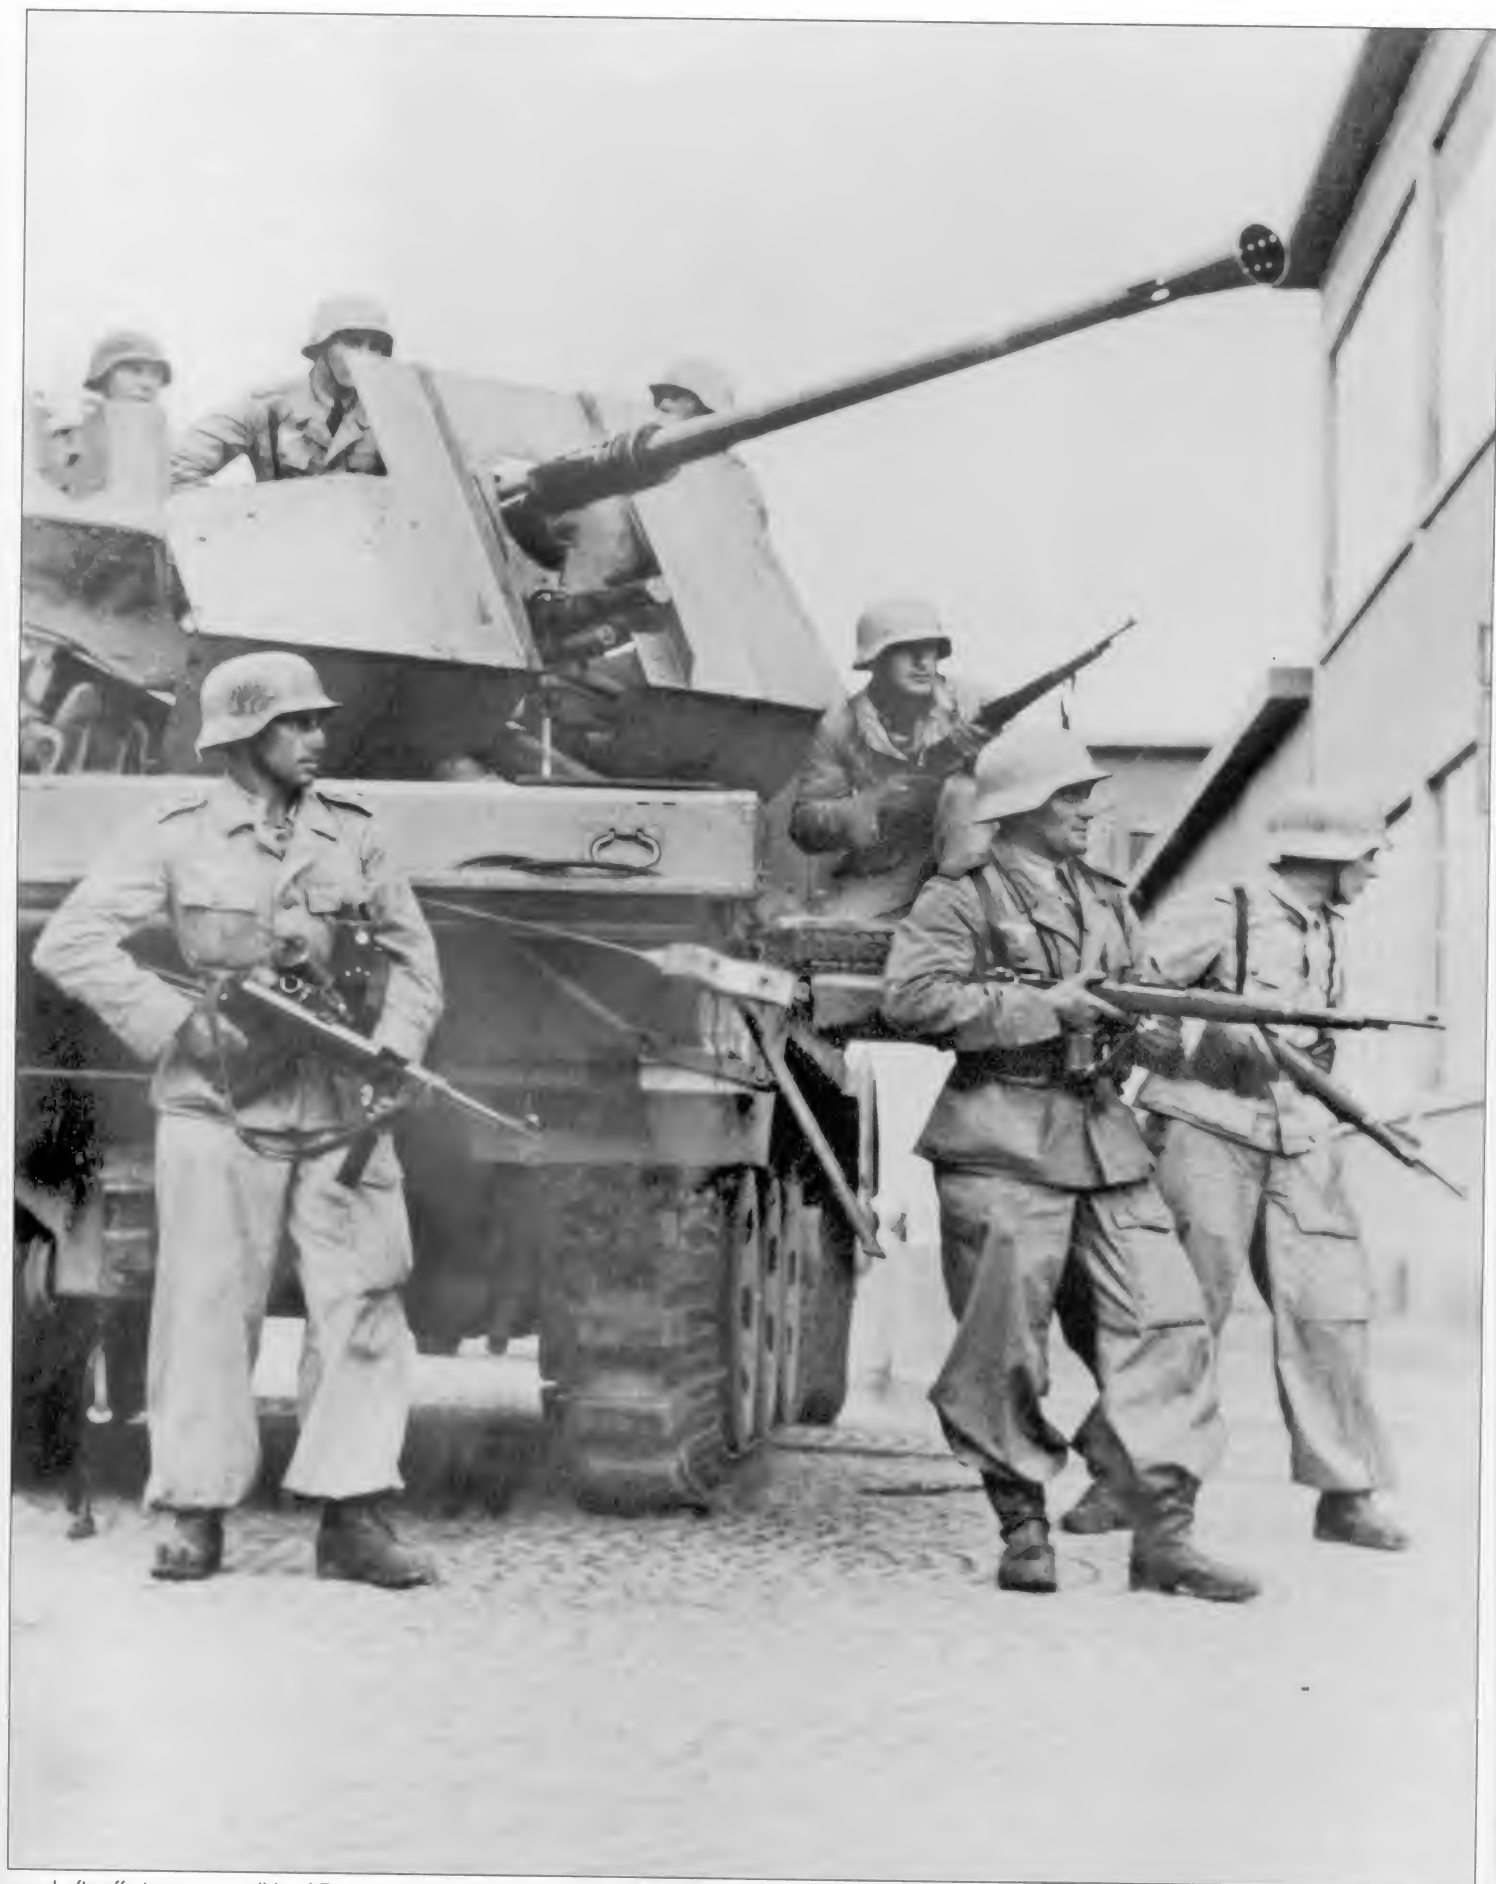
Luftwaffe troops, possibly of Panzer-Division Hermann Göring, dismount to protect a Sd.Kfz.7/2 FlaK half-track in a posed photograph in Italy. The 8-ton Sd.Kfz.7 half-track, normally used as an artillery prime mover, was provided with an armored cab and hood and fitted with a 3.7cm FlaK 36 with 123 being so modified from 1943 to 1945. The separate smaller shield to the left of the gun protects the gunner. The feldwebel (sergeant) to the left, probably the platoon sergeant, is armed with a 9mm MP-40 machine pistol.

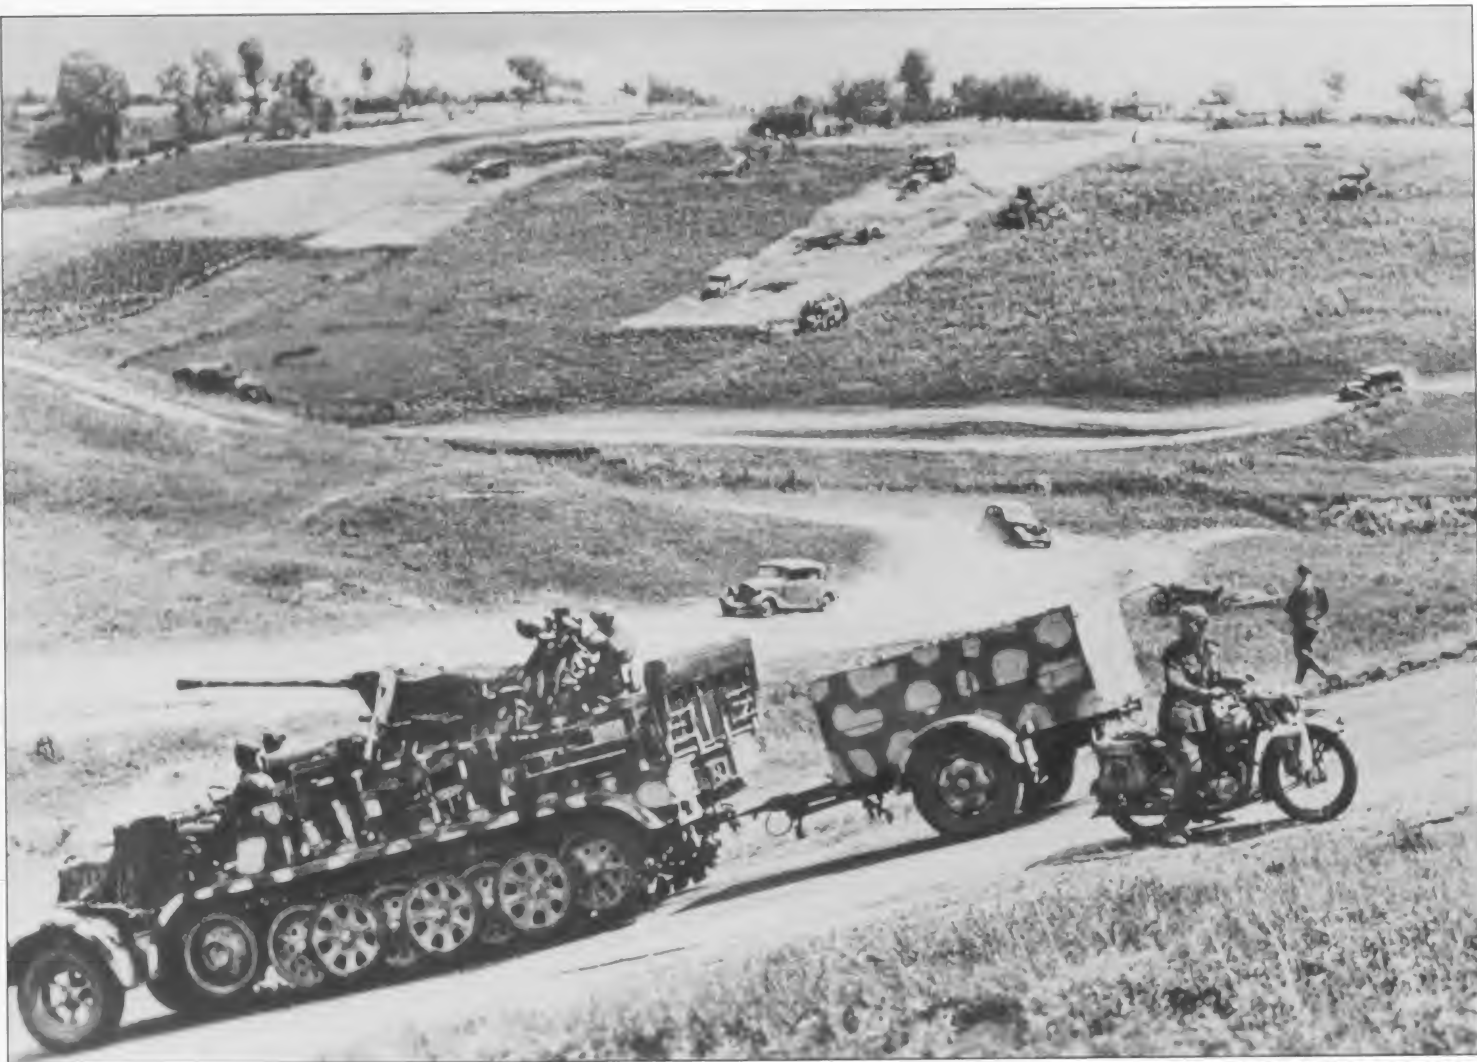
A Sd.Kfz.7/2 3.7cm FlaK 36 half-track pulls its ammunition trailer, which also carried other gun equipment and crew baggage. The FlaK 36 had a practical rate of fire of 80 rounds per minute and a cyclic rate of 160 rounds. The camouflage pattern appears to be dark yellow spots on an olive green on dark gray base. Such contrasting colors and the comparatively regular size of the pattern are not a very effective camouflage scheme. On the hillside are scattered radio vans and staff cars indicating a forward headquarters.

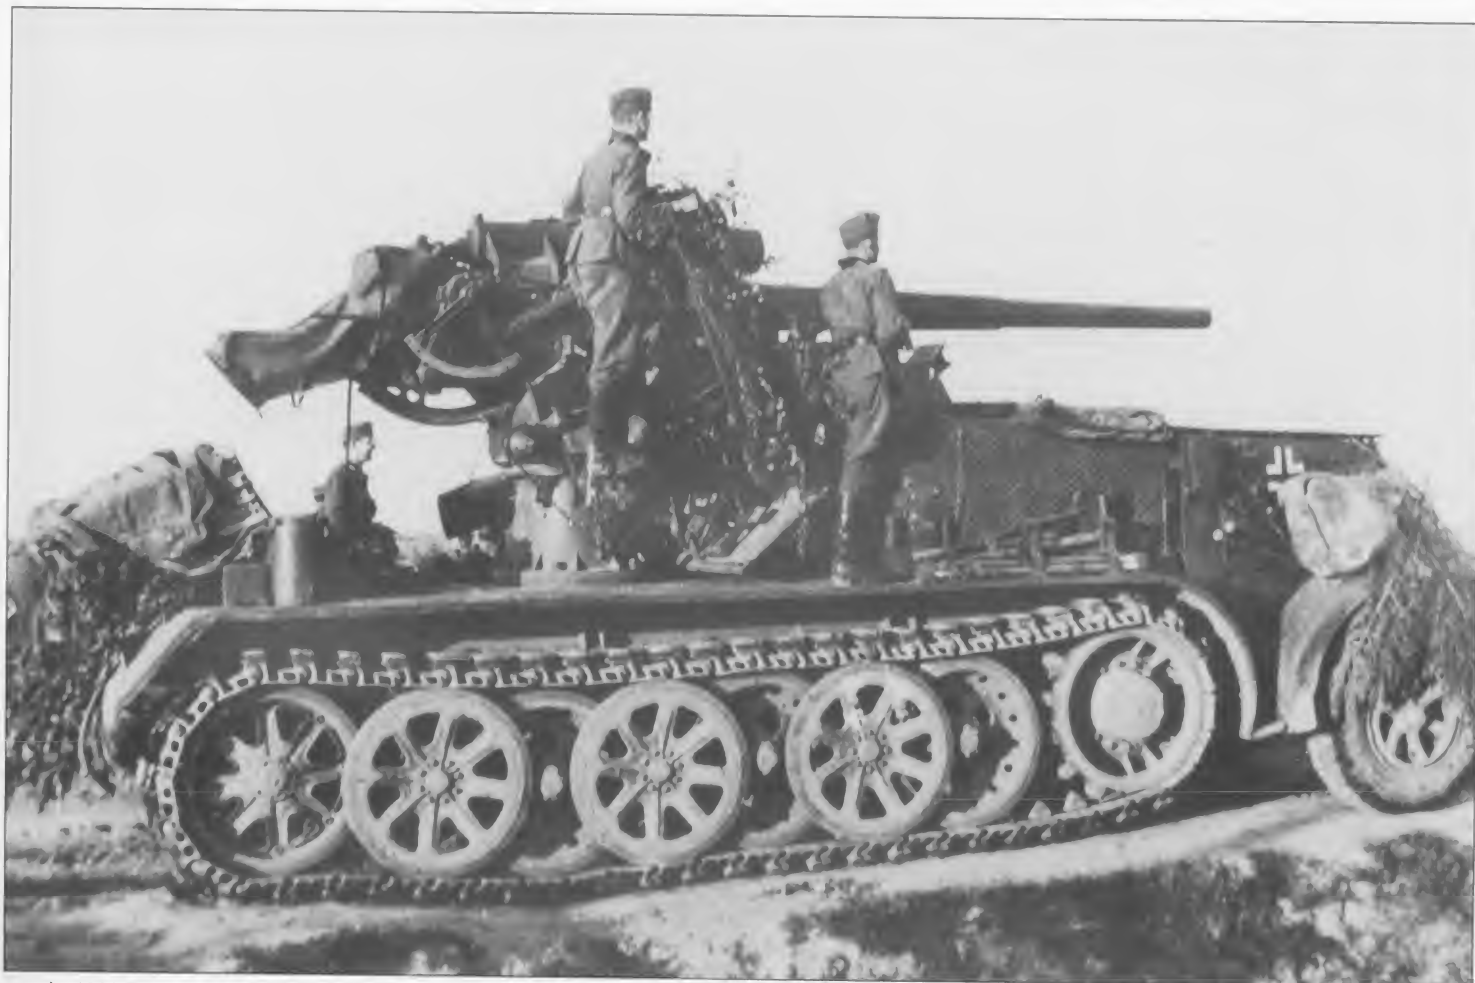
In 1939 8.8cm FlaK 18(Sf.) guns were mounted on 10 12-tonne capacity Sd.Kfz.8 heavy half-tracks in an effort to provide additional mobility for the heavy guns. These were intended for dual role uses of anti-aircraft and anti-tank. The cab and hood were fitted with 14mm armor and two light outrigger jacks were fitted on each side to give the top-heavy weapon stability. Here the outriggers have been stowed.

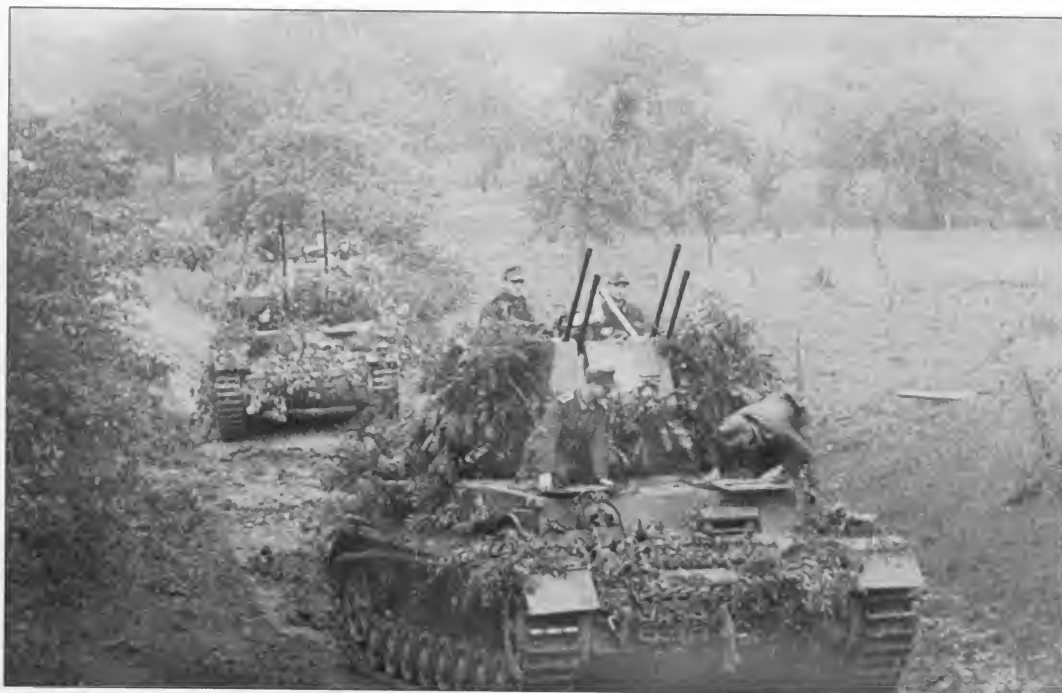
Two Flakpanzer IV 'Wirbelwind' (Whirlwind) somewhere on the Western Front in early October 1944. The first seventeen Flakpanzer IV 'Wirbelwind' were completed in July 1944 and issued to various units beginning in September. These were assembled on rebuilt Pz.Kpfw.IV chassis that had been returned to Germany and mounted the 2cm Flakvierling 38 anti-aircraft gun in a rotating turret. These ones are based on a Pz.Kpfw.IV Ausf.G identifiable by the 30mm armor plates welded to the front of the hull and superstructure. It can be seen how the attached foliage, coupled with its painted camouflage pattern, would aid in concealing the vehicle if it pulled hard into roadside trees and brush when an aircraft appeared.

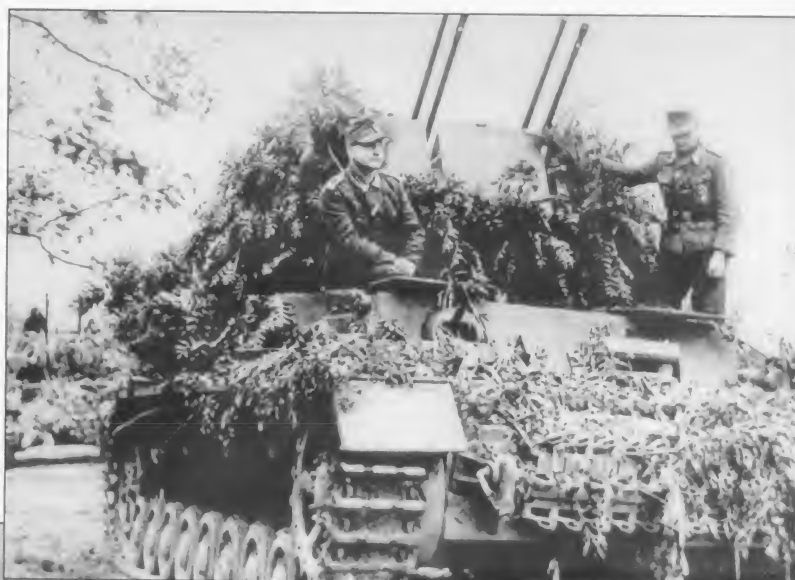
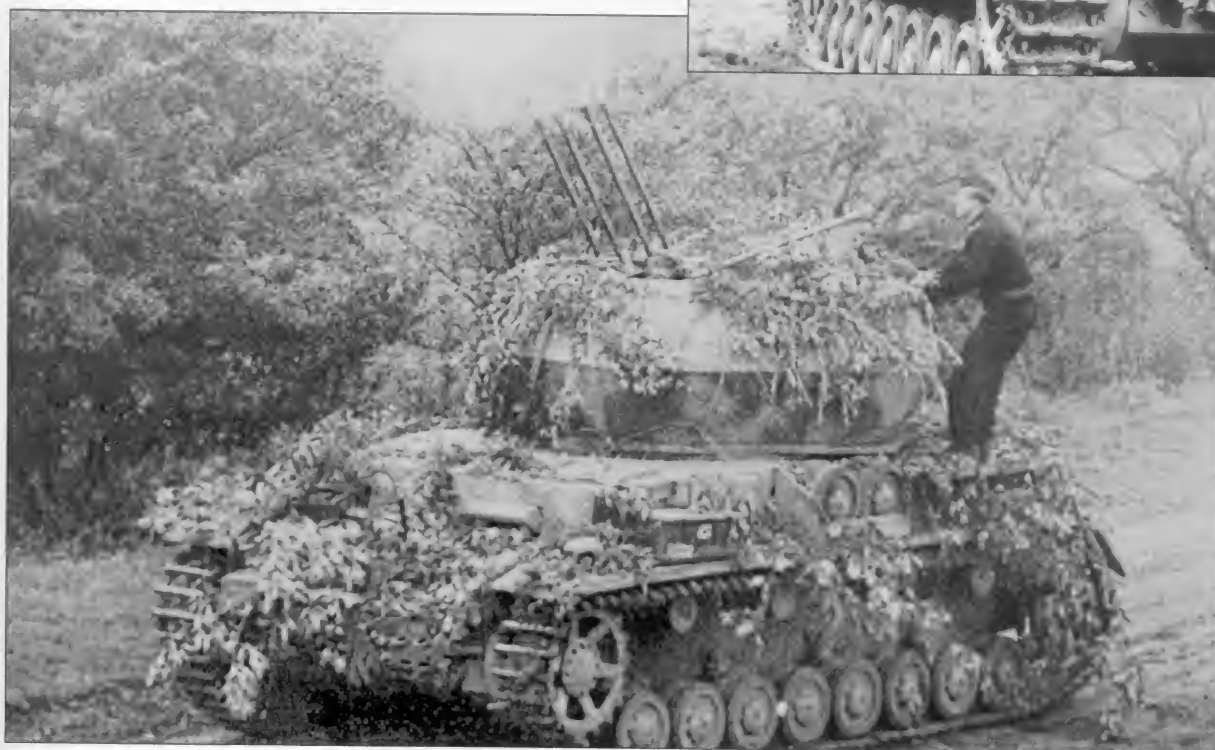
This 'Wirbelwind' appears to have been struck by 5-inch high-velocity aircraft rockets delivered by fighter-bombers. The textured pattern of Zimmerit "anti-magnetic" plaster can be seen on the hull. The plaster was not actually anti-magnetic, but merely provided an insulating material to prevent hand-delivered magnetic antitank shaped-charges from adhering to the vehicle.

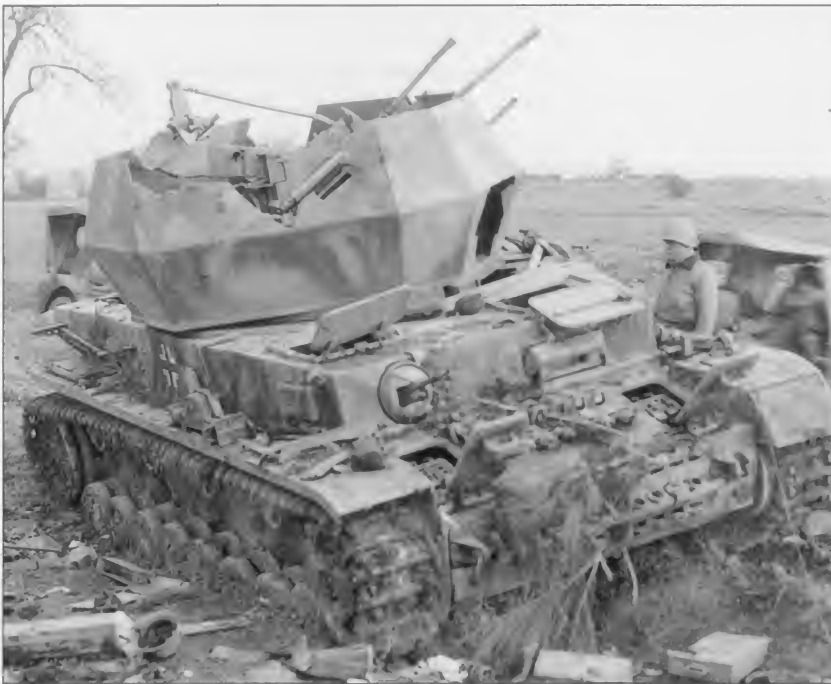
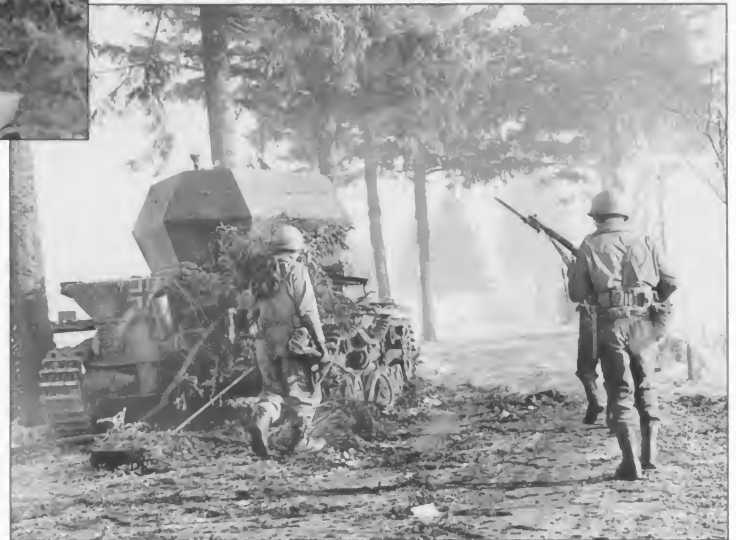
This late production Flakpanzer IV 'Wirbelwind' was destroyed north of Bastogne in January 1945. It was based on the Pz.Kpfw.IV Ausf.J chassis and is fitted with the Flammentöter flame suppressing exhaust pipes. The impact of the round that knocked out this vehicle has blown off one of the four steel return rollers and destroyed two roadwheels.

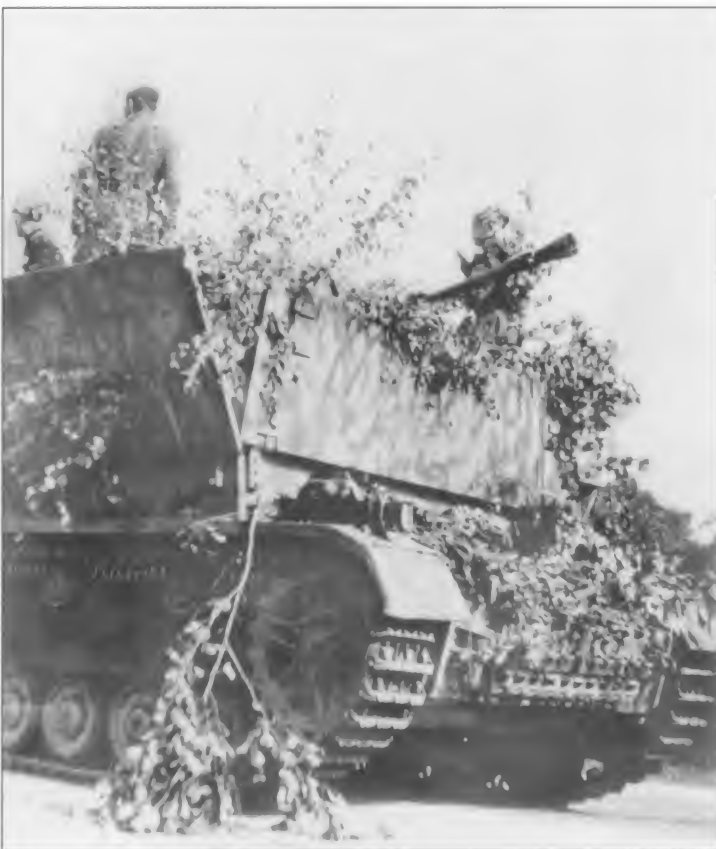
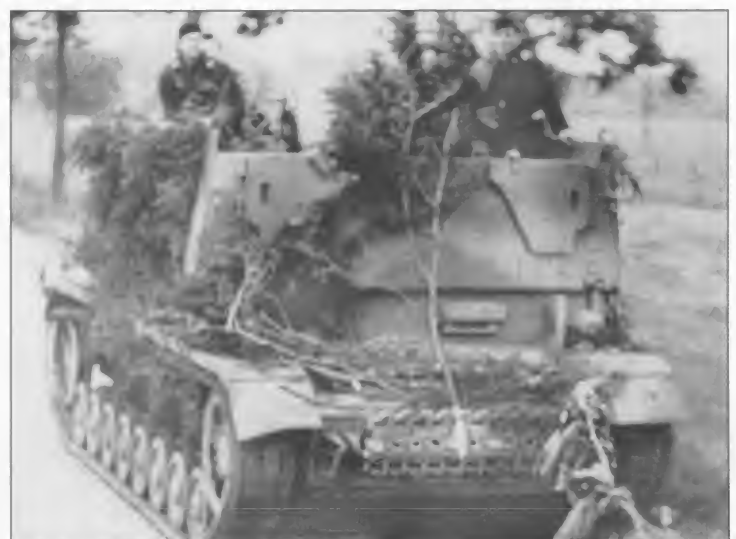
These photos illustrate the 3.7cm Flak 43 mounted on a Pz.Kpfw.IV chassis, the 'Möbelwagen' (furniture wagon), the 3.7cm Flak auf Fahrgestell Panzerkampfwagen IV (Sf.) (Sd.Kfz.161/3). Initially, the first 20 superstructures had double 12mm shields, the next 25 had double 10mm shields and the remainder were fitted with single 25mm shields. While moving the shields were raised. This provided some protection to the crew for shell bursts on all four sides. The gun retained its own shield though to offer some forward protection to the crew when the vehicle shields were lowered. When the forward shield was raised the gun had to be elevated above the shield. The shields had to be lowered in order to operate the gun, as it could not rotate when the shields were up. Beneath the fir branches the vehicle has been painted green and brown over the dark yellow base.

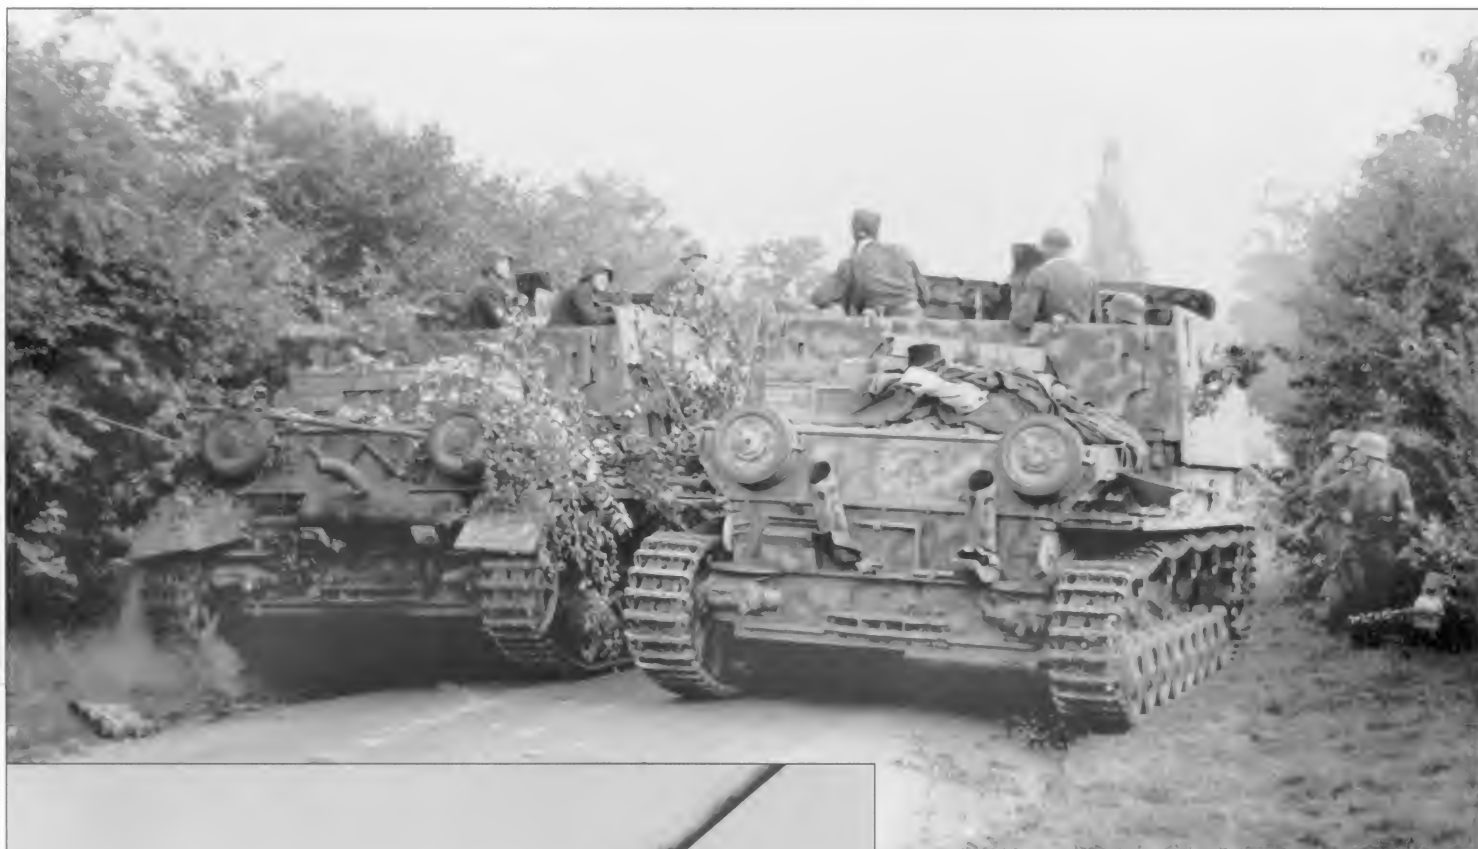
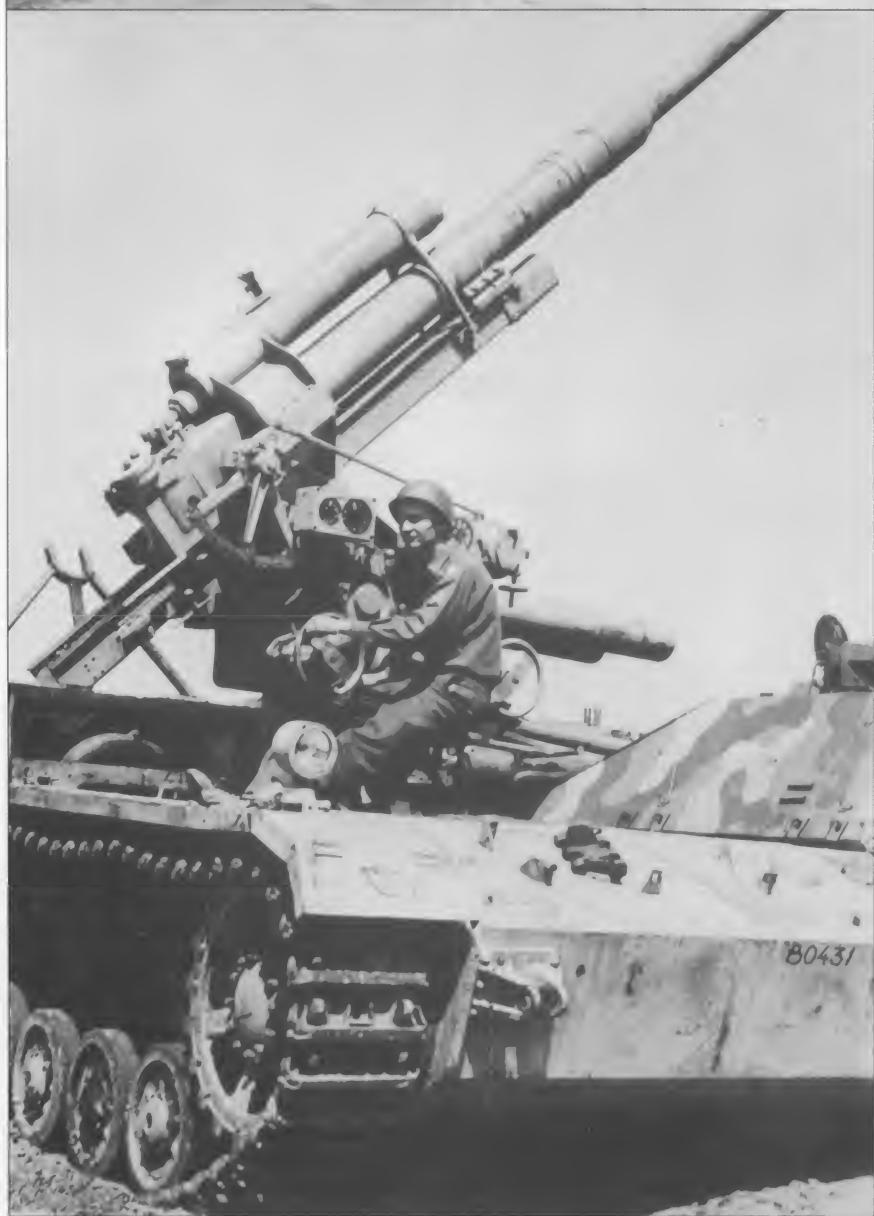
The 'Möbelwagen' was introduced in June 1944 with the first 24 assigned to Panzer divisions in the West where the fighter-bomber threat was most serious. The 3.7cm FlaK 43 L/60 gun was introduced in 1943. Externally it was similar to the earlier 3.7cm FlaK 18, 36, and 37, but it was gas operated rather than recoil as the earlier models. A load of 416 rounds of 3.7cm ammunition was standard. Here, 'Möbelwagen' crews shout encouragement to one another as they pass on a Normandy road. While the vehicles are of different versions, note the rear ends and different exhaust systems, they appear to belong to the same unit because of the similarity of the camouflage patterns including the use of a darker color on the inside of the 3.7cm gun shields. The one on the left looks to be based on a Pz.Kpfw.IV Ausf.H chassis while the one on the right is based on the later Ausf.J chassis and is fitted with the Flammentöter flame suppressing exhaust pipes.
